**Building Inspection Report:
417 Mills Court Benicia, CA.**

Prepared For: Ms. Allison Conner
Inspection Date: December 28, 2023
Report Number: 20231228

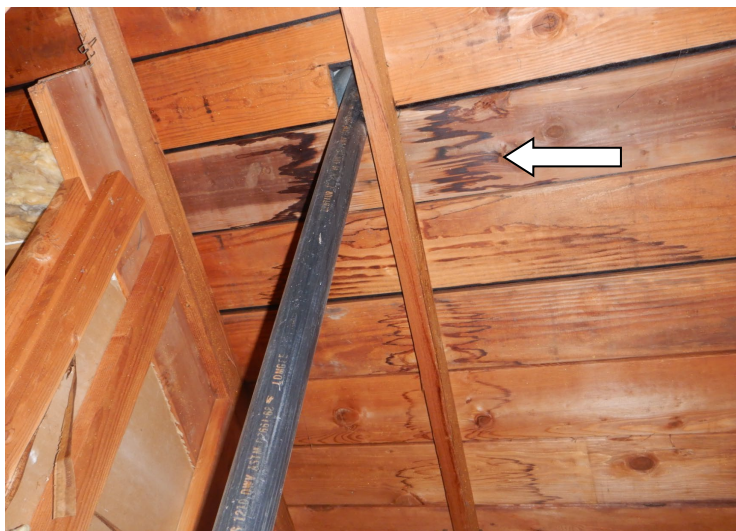
We noted moisture stains on the roof sheathing and trusses, as viewed from inside the attic (See image below of one of the stained areas). These stains may be historic however we cannot be sure. During future rain events we recommend the attic monitored for additional staining and leakage and a qualified roofing contractor retained if active leaks are observed or suspected.

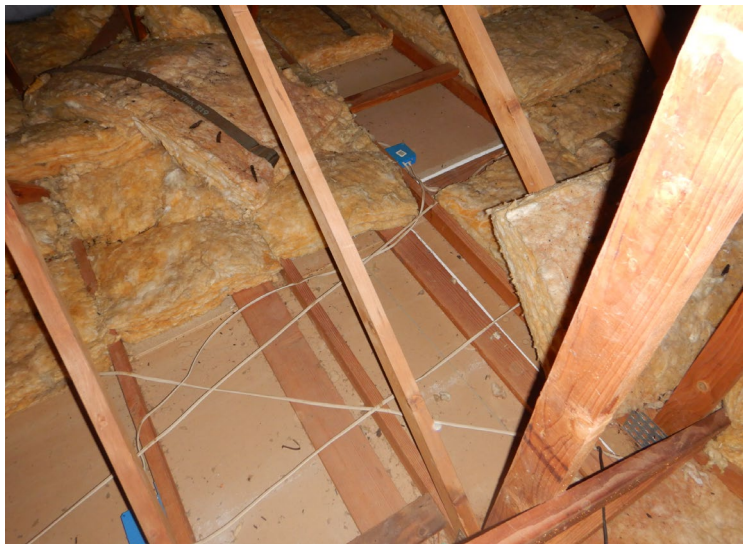
Some of the fiberglass batt insulation has been moved around the attic, likely to allow for the installation of the recessed ‘can’ lights, and areas of the ceiling lack insulation (See image below of one area). We recommend redistributing the batt insulation for complete coverage of the ceiling. Upgrading and adding additional insulation on top of the existing insulation will help to further reduce energy consumption and is recommended.

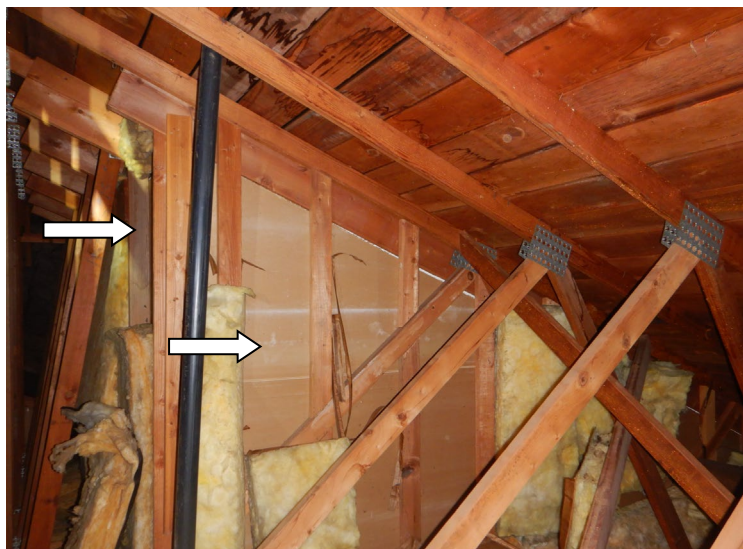
The interior walls of the living room vaulted ceiling have insulation that has fallen out of place (See image below). We recommend replacing the loose insulation and resecuring it to the wall for improved energy efficiency of the home.

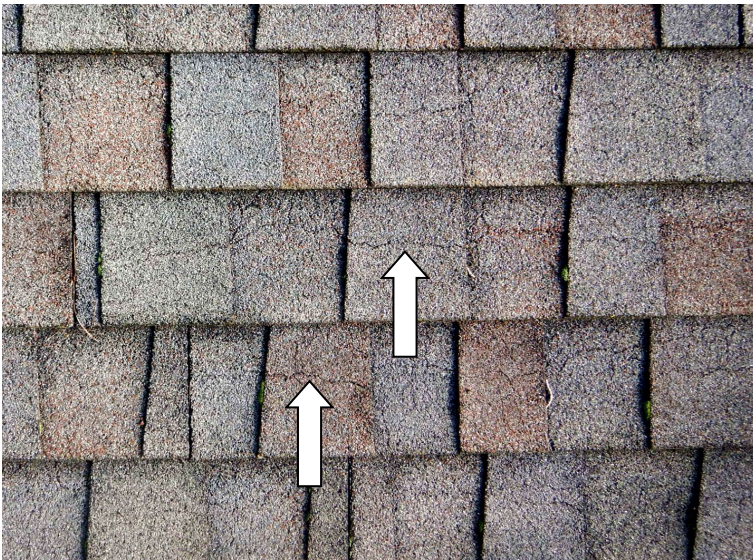
2. The building has composition shingle roofing. We observed some shingles to be damaged above the garage where we suspect tree limbs had dragged across the surface in the past; we also observed unusual cracking that has been associated in the past with a manufacturer's defect (See image in Roofing Section). We recommend further inspection of the cracked shingles by a qualified roofing contractor.

The building has composition shingle roofing. We observed some shingles to be damaged above the garage where we suspect tree limbs had dragged across the surface in the past; we also observed unusual cracking that has been associated in the past with a manufacturer's defect (See image below). We recommend further inspection of the cracked shingles by a qualified roofing contractor.

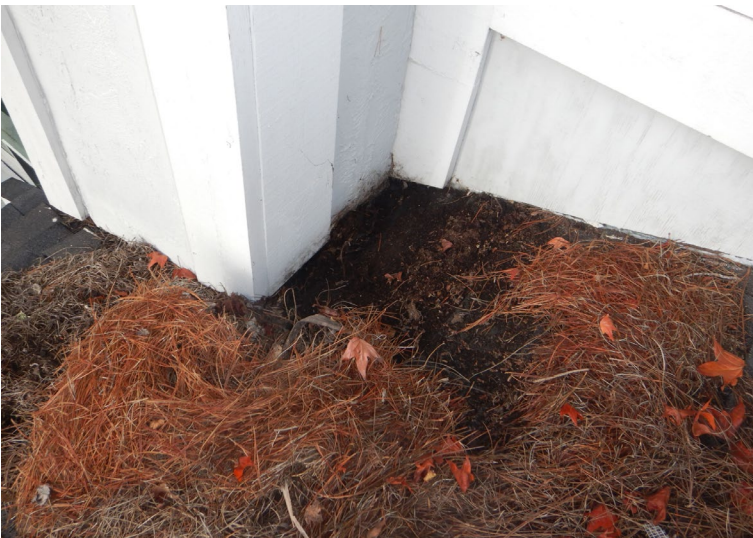
3. The roof surface had accumulated debris (See image in roofing Section) which can block drainage and cause damage to building trim. The roofing should be cleaned and all debris. Removal of debris may be necessary a couple of times each year. Tree limbs near or overhanging the roof should be trimmed as needed.

The roof surface had accumulated debris (See image below) which can block drainage and cause damage to building trim. The roofing should be cleaned and all debris. Removal of debris may be necessary a couple of times each year. Tree limbs near or overhanging the roof should be trimmed as needed.

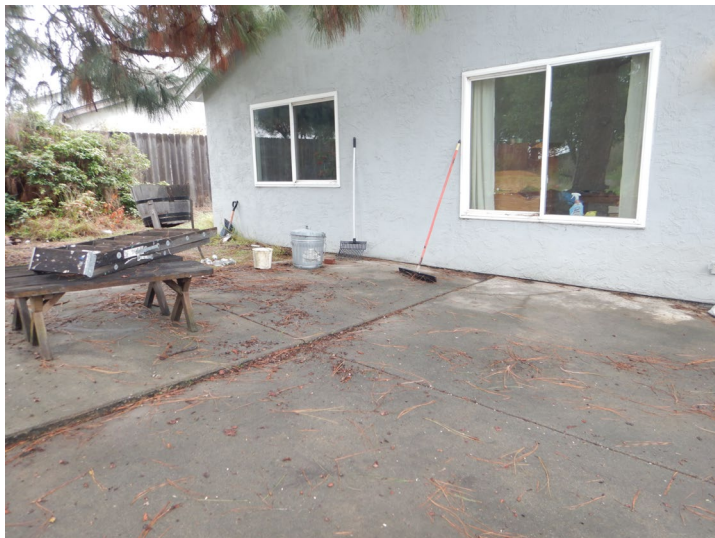
6. The rear patio surface has heaved and is draining towards the house (See image in Exterior Section). This condition can cause the foundation to shift or settle over time. It is difficult to improve this situation without replacing the patio. We recommend the advice and services of a qualified drainage contractor followed by repair or replacement of the patio to correct the drainage at the rear of the home.

The rear patio surface has heaved and is draining towards the house (See image below). This condition can cause the foundation to shift or settle over time. It is difficult to improve this situation without replacing the patio. We recommend the advice and services of a qualified drainage contractor followed by repair or replacement of the patio to correct the drainage at the rear of the home.

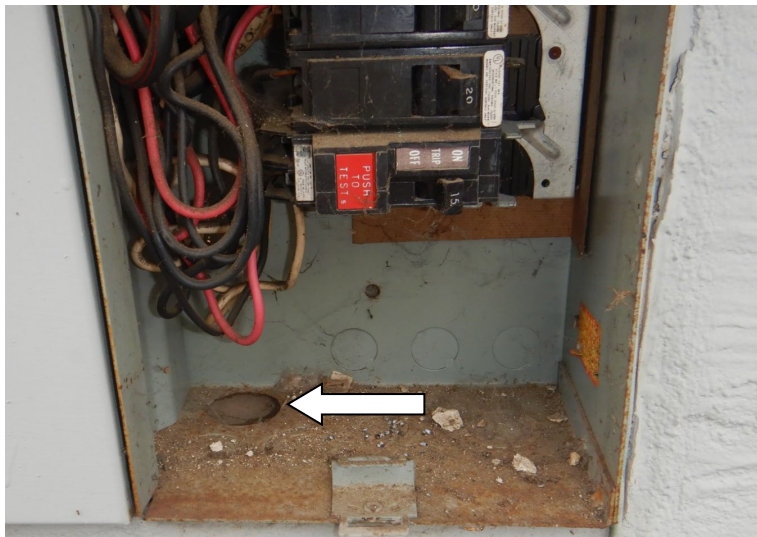
- 9. The panel body has an opening inside (See image in Electrical Section). Panels must be closed to contain fire. A twist out was removed to accommodate a breaker, yet no breaker is installed within the opening. An electrician should install suitable filler plates where needed.
- 10. The date code of the furnace serial number suggests the furnace is approximately 24 years old. However, we cannot be sure of its age. We recommend obtaining the age of the furnace from a heating contractor which would help estimate its remaining service life (See image below of the serial number).
- 11. The drain trap under the kitchen sink is deeper than is recommended and will be prone to accumulation of debris, which could eventually block the drain. We recommend the trap replaced by a qualified plumbing contractor.

The panel body has an opening inside (See image below). Panels must be closed to contain fire. A twist out was removed to accommodate a breaker, yet no breaker is installed within the opening. An electrician should install suitable filler plates where needed.

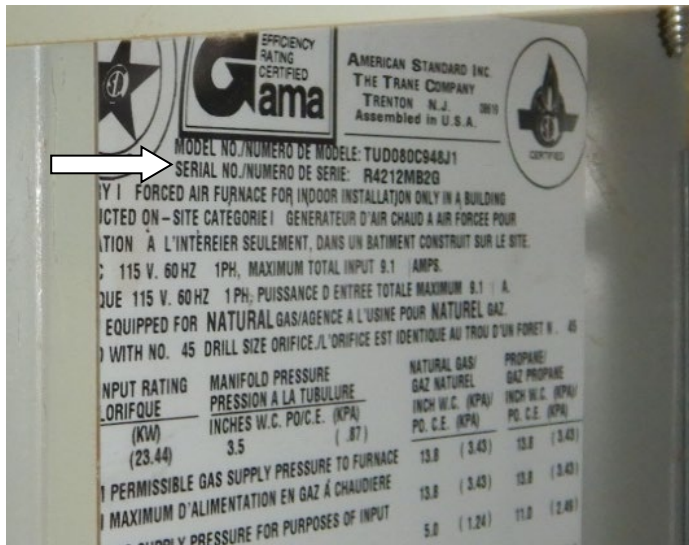
The date code of the furnace serial number suggests the furnace is approximately 24 years old. However, we cannot be sure of its age. We recommend obtaining the age of the furnace from a heating contractor which would help estimate its remaining service life (See image below of the serial number).

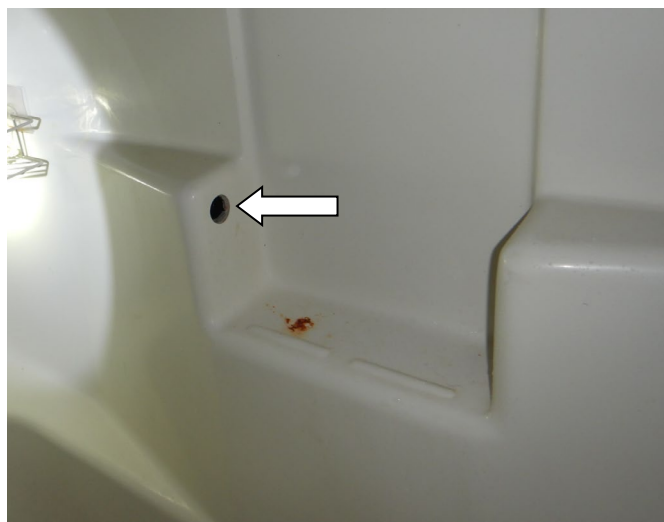
- 14. The fiberglass tub has a large opening where a safety grab bar was removed (See image in Plumbing Section). We recommend the safety grab bar replaced and the hole sealed to prevent moisture intrusion that can damage the building.

The fiberglass tub has a large opening where a safety grab bar was removed (See image below). We recommend the safety grab bar replaced and the hole sealed to prevent moisture intrusion that can damage the building.
